EFFECT OF FIBER ORIENTATION ON THE DELAMINATION BEHAVIOUR OF GLASS-CARBON HYBRID INTERFACE

ABSTRACT

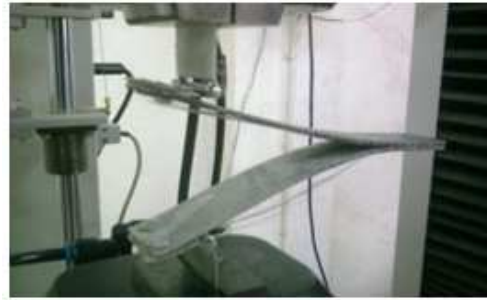
The Loading hinges used to transfer the load from UTM to the specimen was riveted carefully after drilling two holes of 2 mm diameter in the specimen. The sides of the specimens were marked at an equal interval of 5 mm from the crack tip. The end of the hinges are clamped to the vice of the UTM and loaded as shown in Figure 2. The test was conducted at a constant speed of 2 mm/min. The crack extension was monitored through a 12.1 megapixel optical camera with 20X optical zoom. The load and displacement values corresponding to each 5 mm crack extension was manually recorded by visual inspection. Five samples were tested for each type and the load-displacement value taken at each interval is used to calculate the Mode I strain energy release rate (G_{Ic}).

Figure 2: DCB Specimen Being Tested at UTM
